### MEASURING THE EFFECTIVENESS OF VOLUNTARY PLASTIC INDUSTRY EFFORTS: AMRF'S ANALYSIS OF OPERATION CLEAN SWEEP

C.J. Moore, G.L. Lattin, A.F. Zellers

*Algalita Marine Research Foundation, 148 N. Marina Drive, Long Beach, CA 90803, USA*

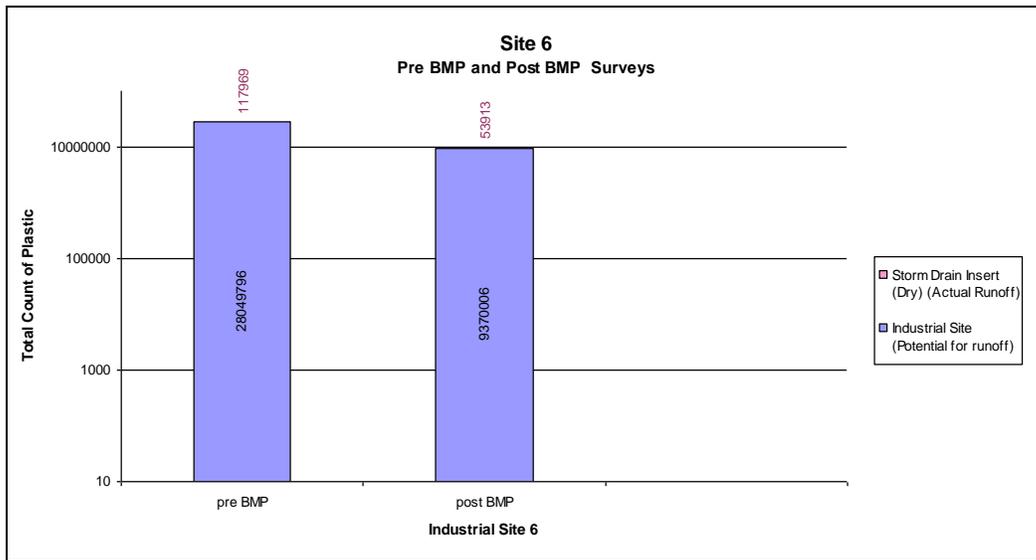
Site 6

1. On the parking lot.
2. By the pellet storage silos on the west and east sides of the main building.
3. By the loading docks.
4. Covering the gravel on the railcar delivery area .
5. On the paved machinery and equipment storage area.
6. Next to the neighboring building on the east side of the facility.

All of these areas continued to contribute lost pellets to the runoff caught by the catch basin insert post BMP.

**By comparing the pre BMP and the post BMP surveys, this facility has improved. However, even though the west area of the facility was cleaner, and there were fewer larger spills at the railroad track area, this facility continues to have a high rate of pellet loss on the ground. Many of these pellets are making it to the storm drain system.** On several occasions, project personnel have observed the pellet trail from the facility to the catch basin. **Going from one hundred thousand pre BMP to fifty thousand pellets post BMP in the catch basin insert samples while representing an improvement, still constitutes excessive pellet loss.**

New BMP measures reported by the management include designating an employee to clean up spills inside the factory. Project personnel observed the use of two sock booms that had been placed in the drainage areas on the west side of the facility. Both booms had pellets trapped on the upstream side of the boom, with only a couple of pellets downstream. **There was no evidence of vacuuming in the yard.**

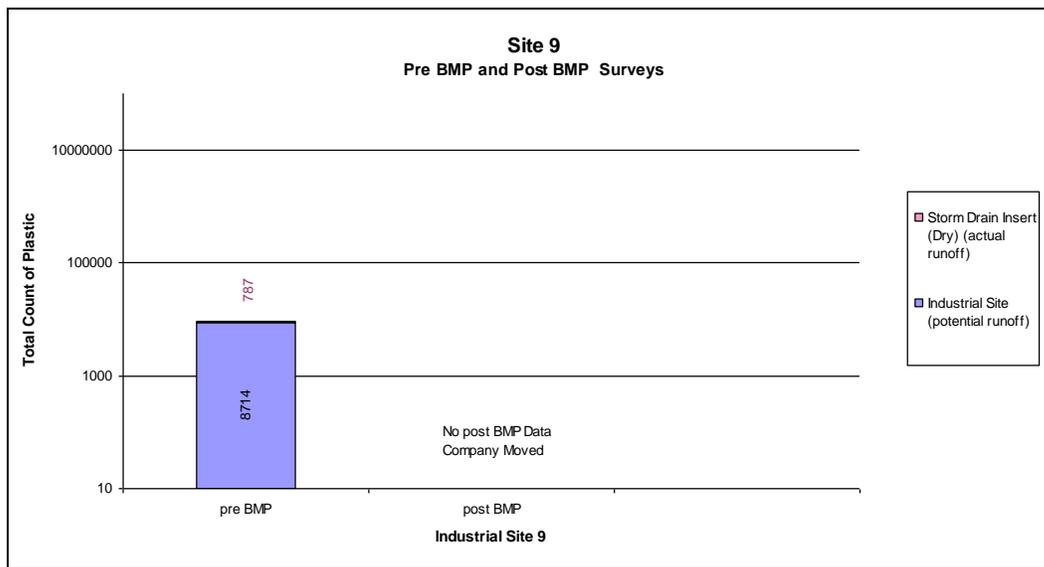
## Site 9

1. On the parking lot.
2. In the driveway by the loading dock.
3. On the platform by the silos.
4. On the gravel at the railcar delivery area.
5. On the paved machinery and equipment storage area.

There were no post BMP Industrial Site samples at this facility. The company moved. They gave permission to the project to install a catch basin insert in a sump by the loading dock. Although this sump does not connect to the storm drain system, during a rain event, it would overflow and floating pellets would come out and possibly flow to a storm drain. This catch basin was sampled during a wet period. It was the only post BMP sample that was taken. There was no indication that the company was moving. When project personnel arrived to do the post BMP sample the facility was under reconstruction. A new layer of gravel had been added at the railroad tracks, covering up many small spills. Project personnel could take pictures, but were not able to obtain permission to take samples.

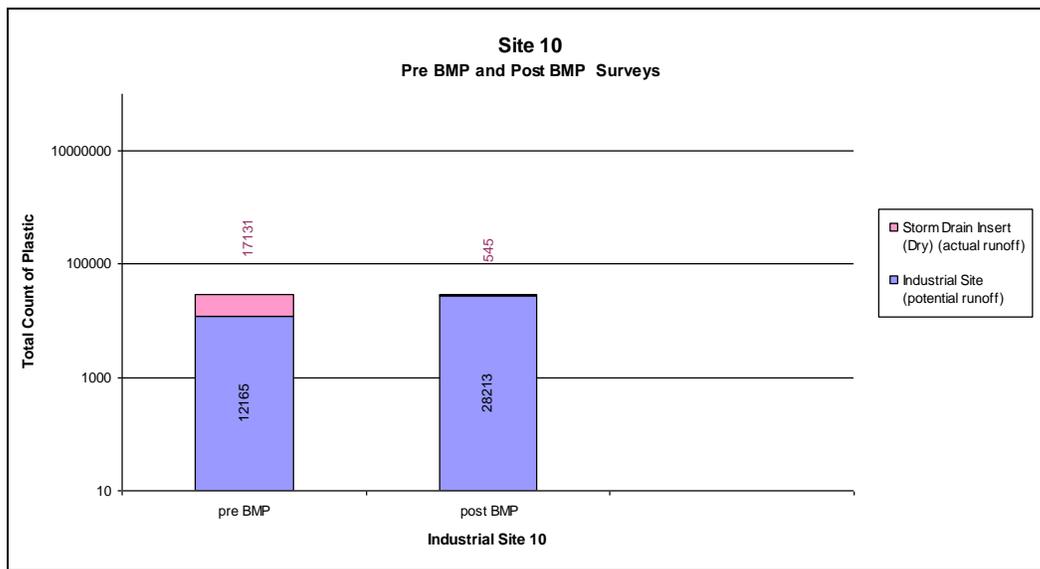
## Site 10

1. The parking lot.
2. The driveway leading to the storage area.
3. The waste bin area.
4. The rear storage area.

By comparing the pre BMP and the post BMP surveys, this facility has remained almost the same, continuing to be a clean facility.

New BMP measures reported by the management included; 1) they change the storm drain insert every 90 days, 2) a vacuum was placed outside as recommended, 3) the Gaylords were covered as recommended, and 4) the dumpster was covered as recommended. Project personnel observed the continued use of the vacuum sweeper, as well as hand sweeping. The storage yard and driveway are both clean, except for very recent small spills.

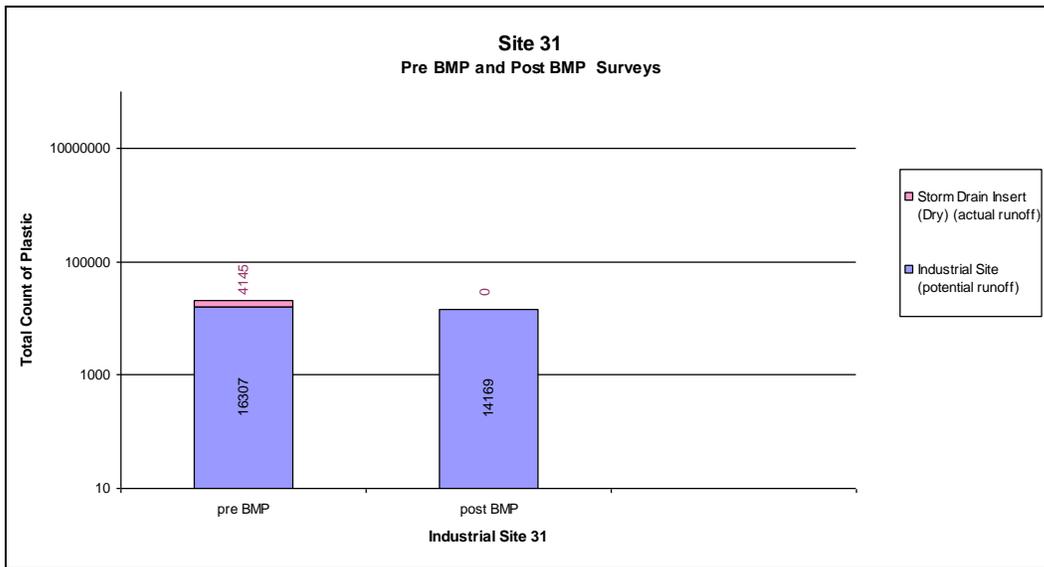
### Site 31

1. The parking lot.
2. The loading dock areas.
3. The two rail car siding areas.
4. Pellets and dust were also found on the edge of the creek.

By comparing the pre BMP and the post BMP surveys, this facility has slightly improved, but is overall pretty much the same. Some pellets and dust are on the ground in the washout area. The asphalt surfaces in some areas are worn down, which traps the pellets. However only a few were observed, reflecting that the area had been cleaned recently.

Project personnel are not aware of any new procedures since the pre BMP monitoring. This is a very large and relatively clean facility, with a significant pellet loss problem during rain events (all catch inserts are pulled to prevent flooding). Project personnel observed the use of manual and driven vacuum sweepers.

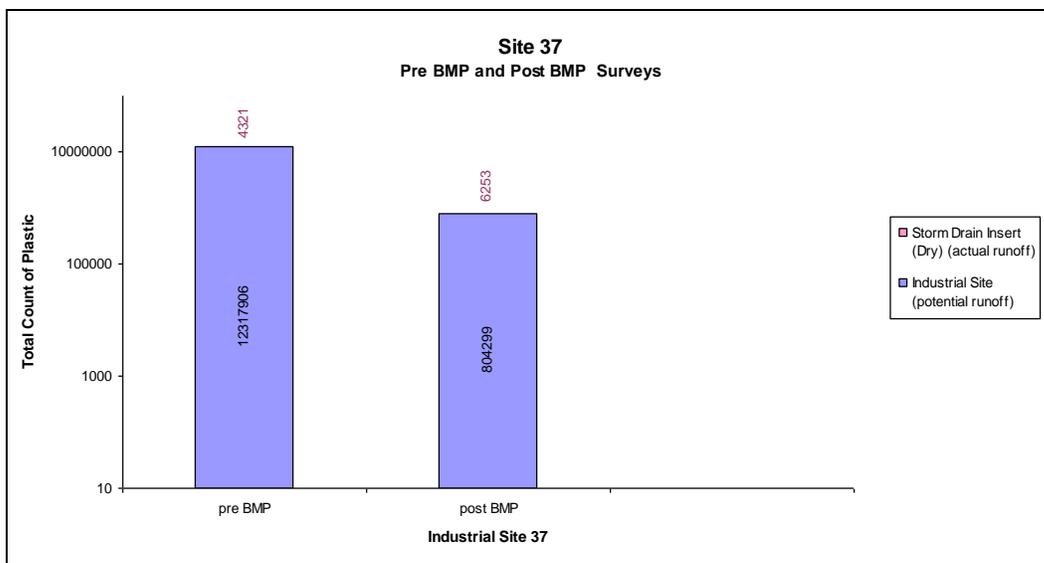
Site 37

1. The public sidewalk on two of the four sides of the facility.
2. The rail yard area behind the facility.
3. The public street and gutter.
4. The catch basin near the rail yard.

This facility has improved, although it was not formally part of the BMP Evaluation sites. We did not sample on their facility, but company personnel observed that the storm drain insert and surrounding areas were being monitored. They made an effort to clean the rail tracks behind their facility, especially nearest the street. There continues to be some pellet loss on the sidewalk and in the gutter leading to the storm drain.

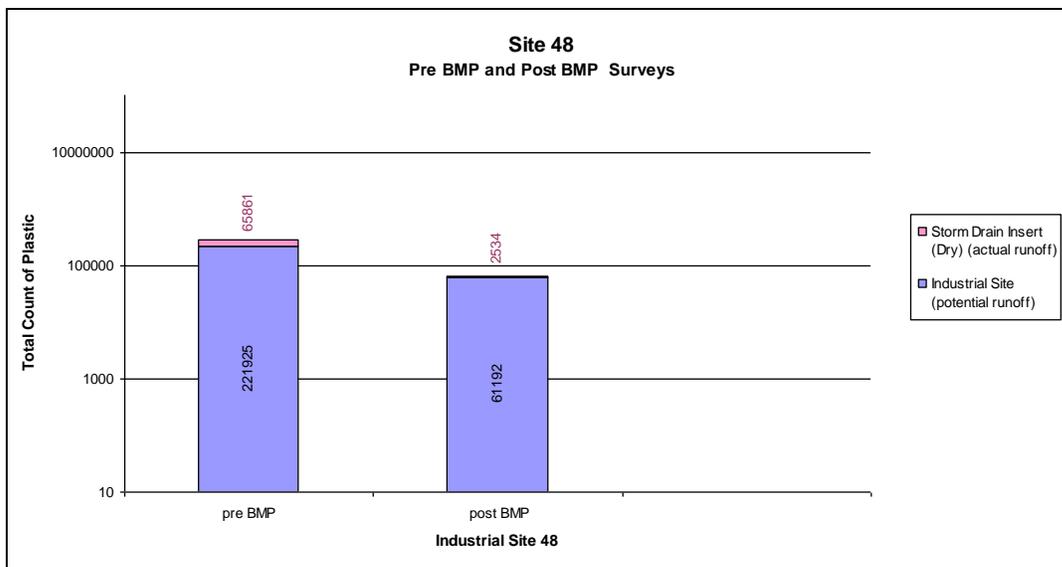
Site 48

1. The front parking, loading dock area and the side of the neighboring building.
2. The waste bin area.
3. The driveway to the rear of the building.
4. The rear receiving dock area.
5. The bag house for the cutting operation.

By comparing the pre BMP and the post BMP surveys, this facility has improved.

This is the only company that has taken our advice to purchase a shop vac. It is used with a long extension cord to clean inside and outside. Deployment is based on visual assessment of need and there is no regular schedule for vacuuming. Each employee is trained to clean up spills at meetings to discuss pellet loss recommended by the project. They reported having had such meetings at the time of post BMP monitoring. They put up the OCS posters with clear acrylic sheet covers in prominent places in the warehouse front and back.

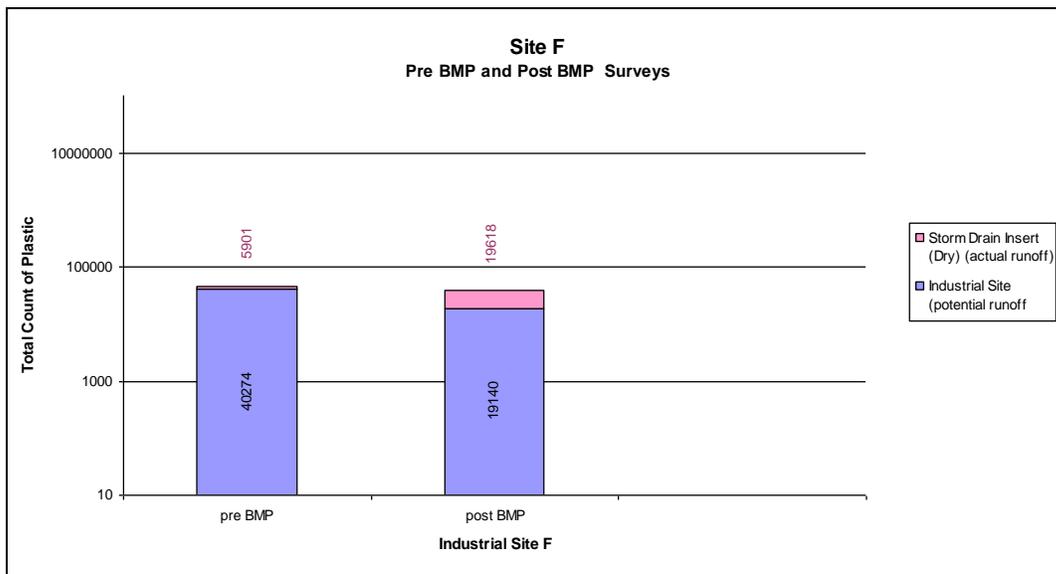
## Site F

1. The rear silo area.
2. The delivery/storage area.
3. The sidewalk.
4. The dumpster area.
5. The gutter on the street in front of the company.

**By comparing the pre BMP and the post BMP surveys, this facility has improved in pellets on the ground subject to runoff, but actual pellets in the catch basin inserts have gone up.**

No suggestions for BMPs were adopted. Management stated that they sweep up and recycle pellets every other day based on visual inspection at the beginning of the shift. They have one cleanup person, but others can help. Owner said he saw a delivery company sweeping pellets back into the delivery truck.

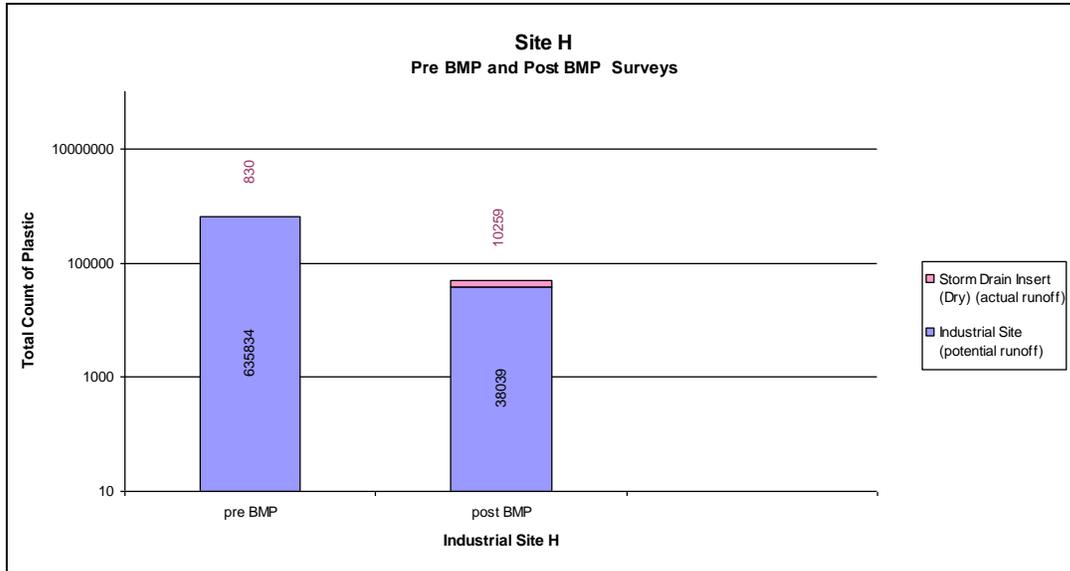
## Site H

1. The pipe storage area on the side of the building.
2. The parking lot.
3. The sidewalk and gutter on the street.

**This facility has improved, although it was not formally part of the BMP Evaluation sites.** They did allow us to sample front of the facility during the pre BMP monitoring and allowed us to come back for the post BMP monitoring to do the same area. **They continue to have spills of**

plastic fragments (regrind) and pellets in the driveway, and at the side of the driveway. There was considerably more plastic present in the post BMP catch basin samples.

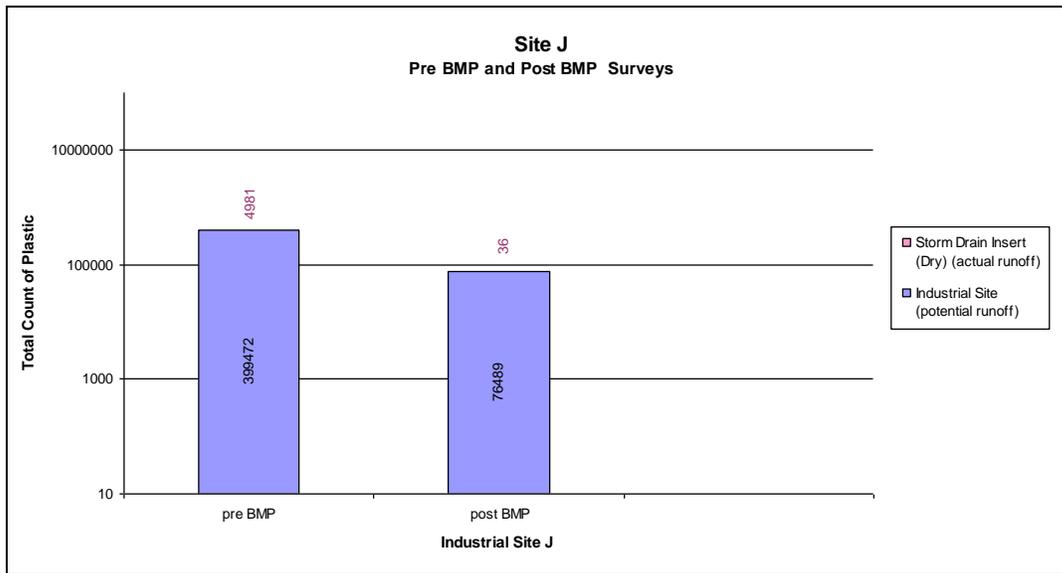
Site J

1. Street level loading and unloading areas.
2. Box and bag handling areas.
3. Regrind/recycling areas.
4. Warehouse storage area.
5. Waste disposal dumpster area.

By comparing the pre BMP and the post BMP surveys, this facility has improved.

New BMP measures reported by the management are being established all the time. They have established cleanup stations and each employee does their cleanup. The manager also said they had had a training session. They have put plastic bags inside their Gaylord containers that they use for Roto Mold Scrap to prevent sawdust from escaping. However some sawdust had escaped and was on a pallet. There was plastic debris observed on both sides of the street though in a lesser degree. Plastic shavings were observed on the sidewalk and in the tree wells. Spills of plastic feedstock powders (blue, red and green) were visible in the parking lot. And plastic dust was visible on the vertical face of the curb on the public street.

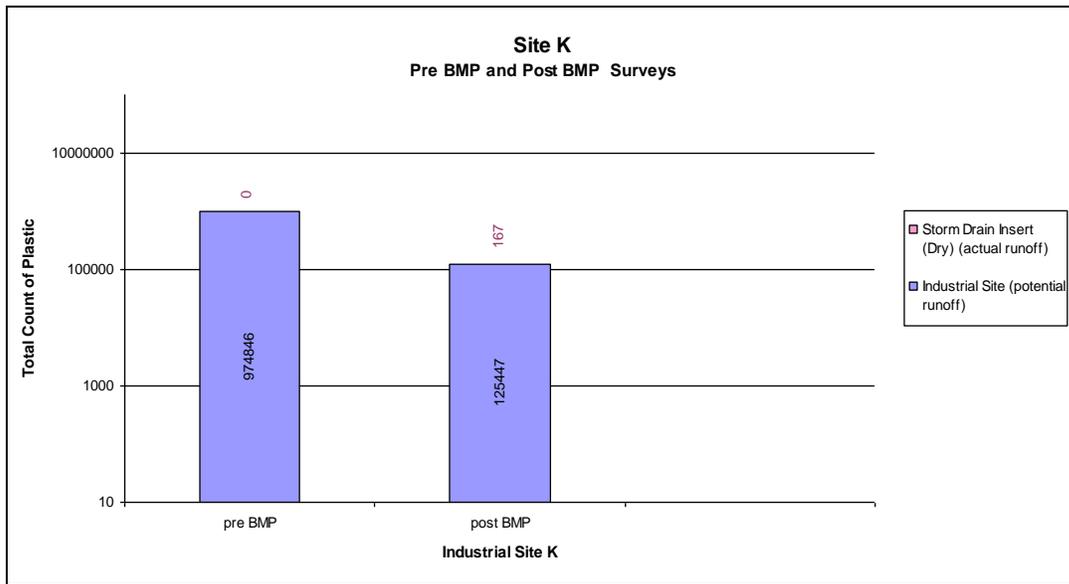
## Site K

1. The parking lot and dumpster area.
2. The truck delivery and loading area.
3. The rail yard which is partially paved.
4. The area behind the facility where powders are filtered out of the pellet delivery system.

**By comparing the pre BMP and the post BMP surveys, this facility has improved.**

New BMP measures were observed at the back of the facility in the dust collection system, which now has a sock taped around the automatically opening valve which blows out dust, so the amount that reaches the ground is reduced. **A way in which pellet loss is worse is that there were no pans under the railcar valves, and the spills on the ground by the railcars were not contained. Pellets were in evidence in the ditch leading to the storm drain by the rail car. The dumpsters had only a small amount of pellets around them, and the dumpsters were covered.**

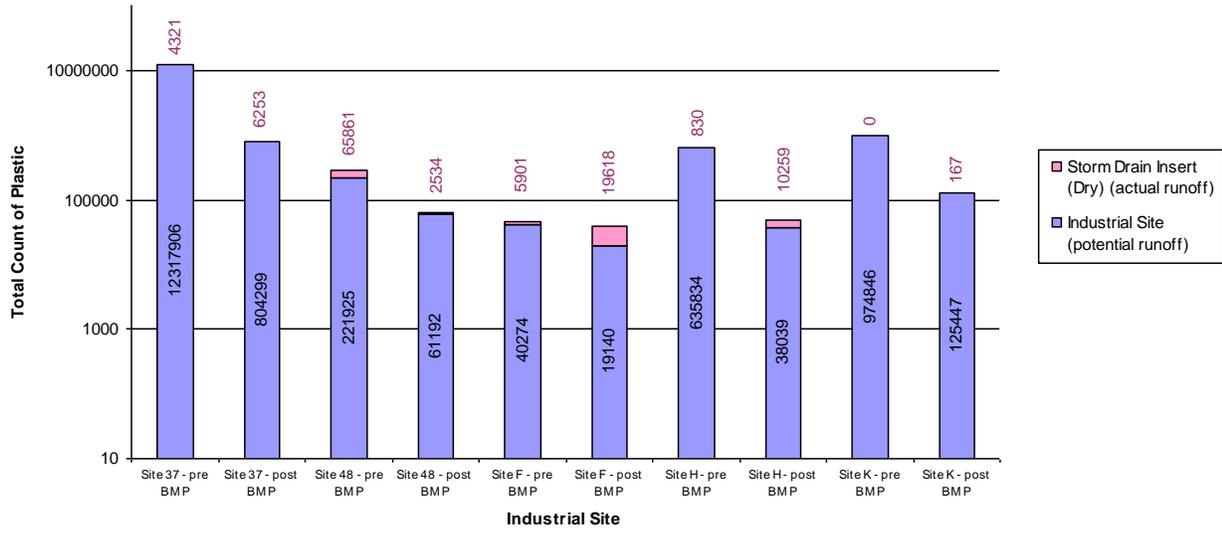
**Los Angeles River Watershed**  
Pre BMP and Post BMP Industrial Site Surveys

**The project found plastic pellets and particles in and on rail yard gravel, combined with on site spills, to harbor 42.7 million plastic particles greater than 1mm in size capable of running off into the storm drain system prior to BMP implementation. The count after BMP implementation was 10.5 million.** Particles that would have entered the storm drain system during dry weather had the project not installed catch basin inserts near the facilities pre-BMP totaled 0.2 million and 0.09 million post-BMP. These particles were taken directly from the inserts.
